# Manhole Inspection Summary

Manhole # S15M\_\_005MH

Insp Date: **3/11/08 2:27 PM**

**Location** Address: **2630 hafer st**

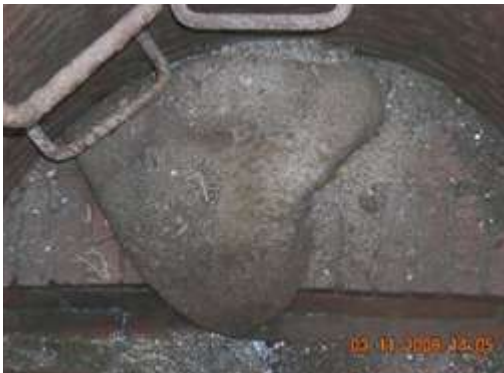
Defect 1

Condition: ☐ Sound ☐ Cracked ☐ Root Intrusion ☐ Deteriorated ☐ Leaks ☒ **Debris**

debris on bench

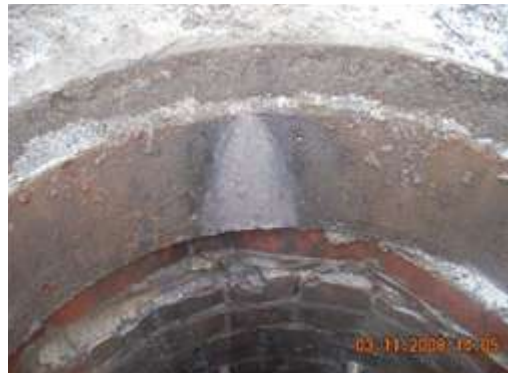
Defect 2

Infiltration: ☐ None ☒ **Joint** ☐ Cracks ☐ Mortar ☐ Roots ☐ Wall

inflow and infiltration evidence

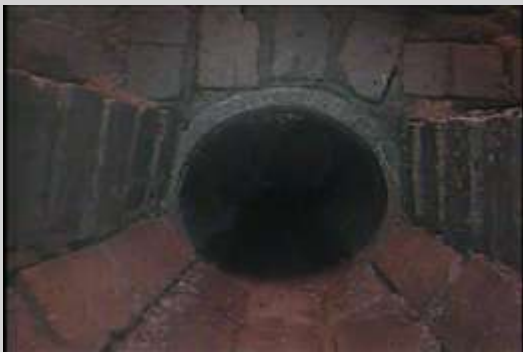
12 O'Clock Outflow

8 in. Circular Gravity Sewer  
Pipe Out @ 12 O'Clock

Pipe Height: **8.4** (in.) Rod and Bar (Angled)  
Pipe Material: **Clay** ☐ Pipe Lined  
Invert Depth: **7.95** (ft.) Flow Characteristics: **Slow**  
Deposits: ☒ None ☐ Mud ☐ Sludge ☐ Debris ☐ Grease  
Silt Depth: **0** (in.) Deposits Extent:  
Infiltration: **None** Pipe Seal Cond: **Sound**

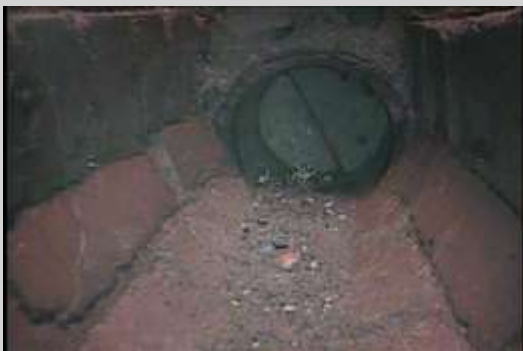
6 O'Clock Inflow

0 in. Circular Gravity Sewer  
Pipe In @ 6 O'Clock

Pipe Height: **6** (in.) Rod and Bar (Angled)  
Pipe Material: **Clay** ☐ Pipe Lined  
Invert Depth: **7.47** (ft.) Flow Characteristics: **None**  
Deposits: ☒ None ☐ Mud ☐ Sludge ☐ Debris ☐ Grease  
Silt Depth: **0** (in.) Deposits Extent:  
Infiltration: **None** Pipe Seal Cond: **Sound**

Connects To: **Stub connection / abandoned**

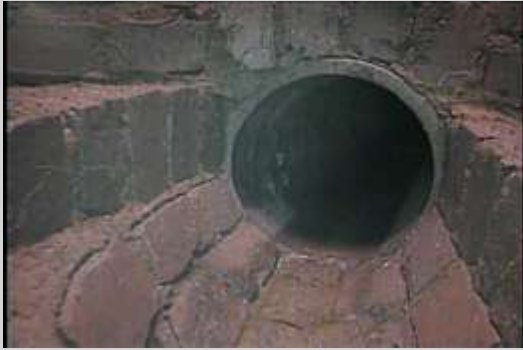
9 O'Clock Inflow

8 in. Circular Gravity Sewer

Pipe In @ 9 O'Clock

Pipe Height: **8.4** (in.) Rod and Bar (Angled)

Infiltration: **None** Pipe Seal Cond: **Sound**
